**Flood Control Project Maintenance
Levee Inspections**

Fall 2011 Levee Maintenance Deficiency Summary Report

Sacramento River Basin

Reclamation District No. 0900 West Sacramento

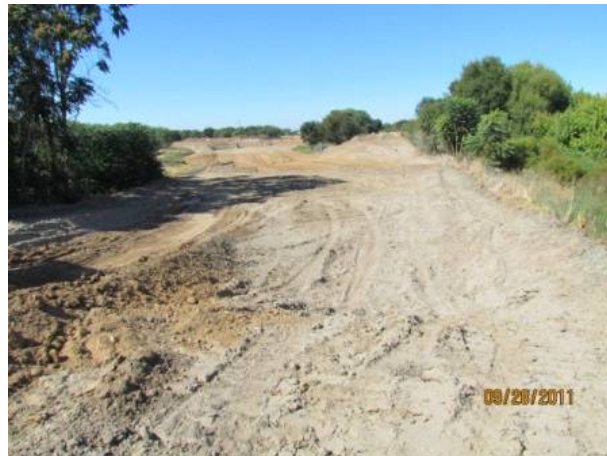
Levee Mile Report Line	4
Start Levee Mile	2.29
End Levee Mile	2.29
Location	Land Side
Category	Earthen Levee
Item	Slope Stability

Slope instability was caused due to vehicular traffic on the landside and crown of the levee looking upstream.

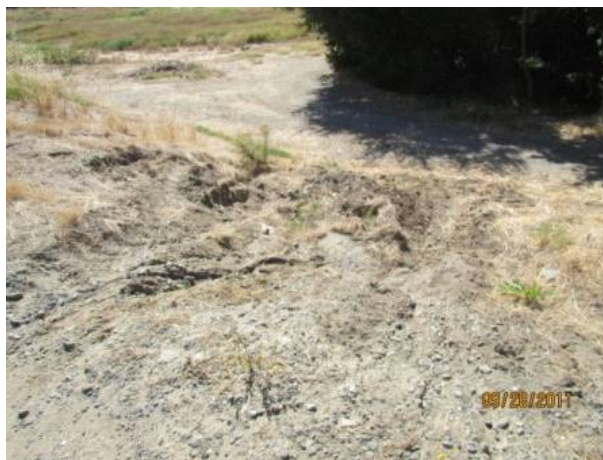
Slope instability was found on the landside of the levee looking upstream.

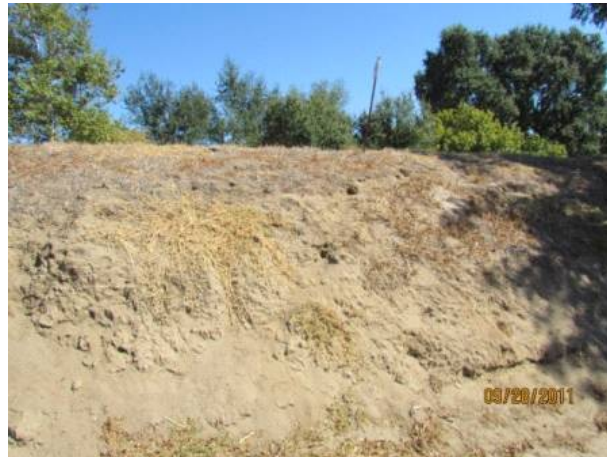
Levee Mile Report Line	15
Start Levee Mile	2.53
End Levee Mile	2.53
Location	Land Side
Category	Earthen Levee
Item	Animal Control

Rodent holes were found on the landside slope of the levee. The picture was taken from toe of the levee looking towards the crown.

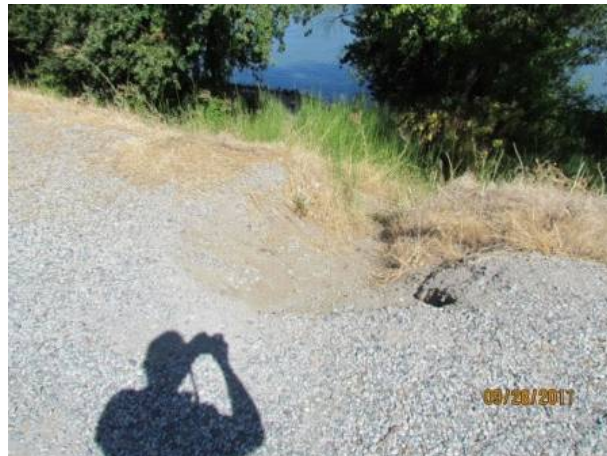
Levee Mile Report Line	16
Start Levee Mile	2.53
End Levee Mile	2.53
Location	Water Side
Category	Earthen Levee
Item	Slope Stability

Slope instability was found on the waterside of the levee looking upstream.

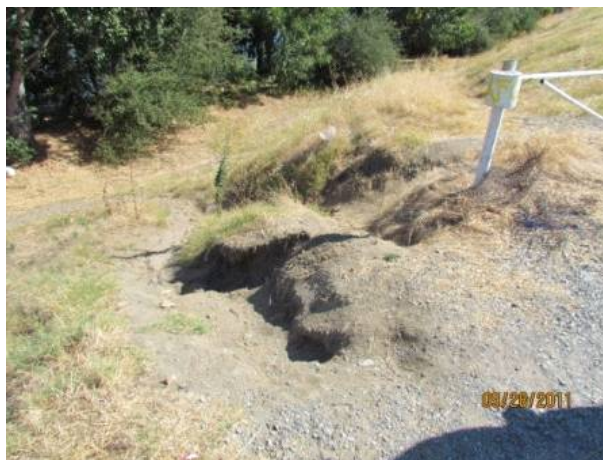
Slope instability was found on the waterside of the levee looking upstream.

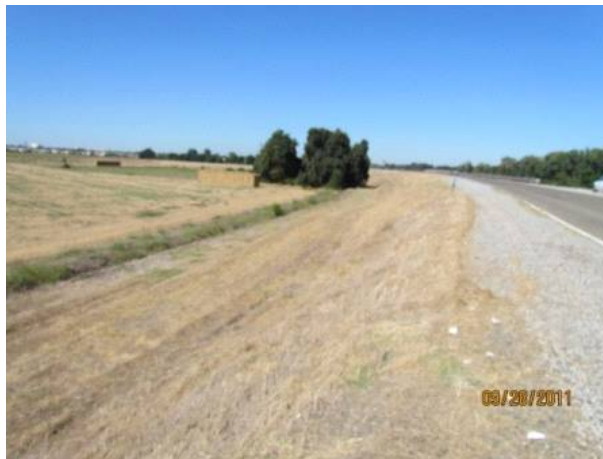
Levee Mile Report Line	24
Start Levee Mile	2.66
End Levee Mile	3.02
Location	Land Side
Category	Earthen Levee
Item	Vegetation

Vegetation on the landside of the slope is in acceptable condition. The picture was taken from the crown looking downstream.

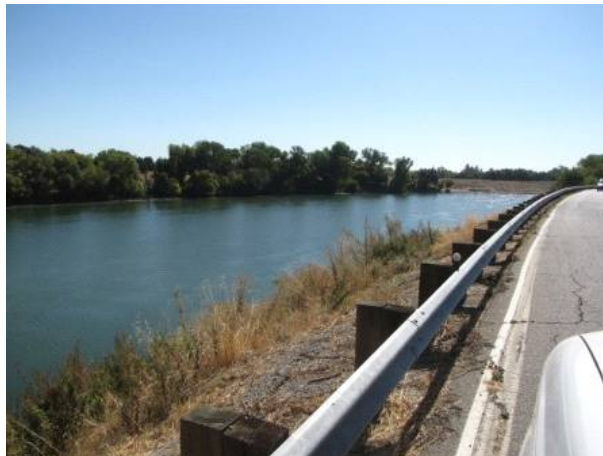
Levee Mile Report Line	25
Start Levee Mile	2.90
End Levee Mile	2.90
Location	Water Side
Category	Earthen Levee
Item	Vegetation

View of vegetation within the top 20' of the waterward slope looking downstream.

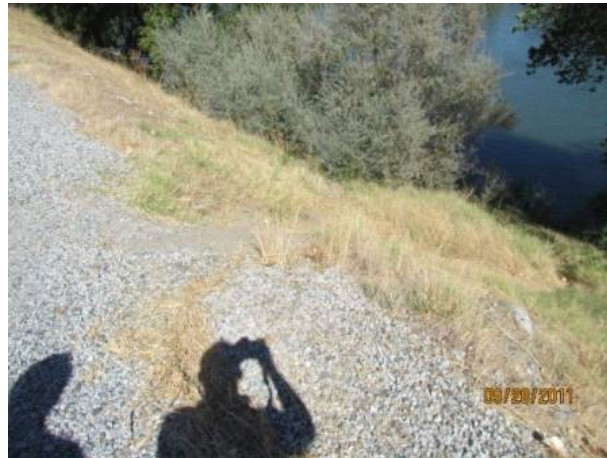
Slope instability was found due to foot traffic on the waterside of the slope looking upstream.

26	3.02	3.02	Earthen Levee	Slope Stability	WS	M	Repair the levee slope damaged by foot traffic and prevent access where possible.	38.544874 ° -121.512438 °	38.544874 ° -121.512438 °	317 Y
27	3.14	3.14	Earthen Levee	Slope Stability	LS	M	Repair the levee slope damaged by vehicle traffic and prevent access where possible.	38.543305 ° -121.512754 °	38.543305 ° -121.512754 °	323 Y

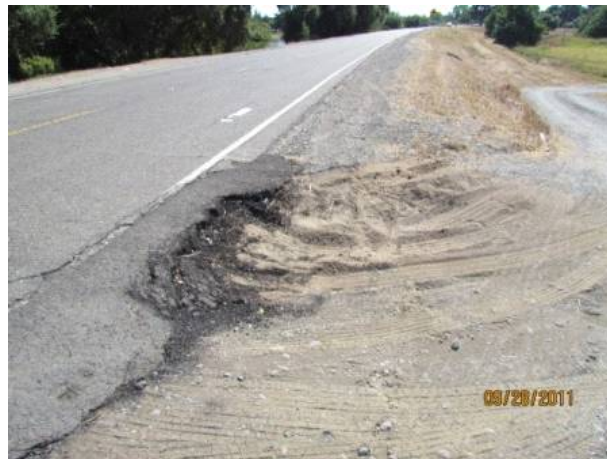
Levee Mile Report Line	27
Start Levee Mile	3.14
End Levee Mile	3.14
Location	Land Side
Category	Earthen Levee
Item	Slope Stability

Side curb was damaged due to vehicular traffic and if not repaired then it might cause instability on the levee in future. The picture was taken from the crown looking downstream.

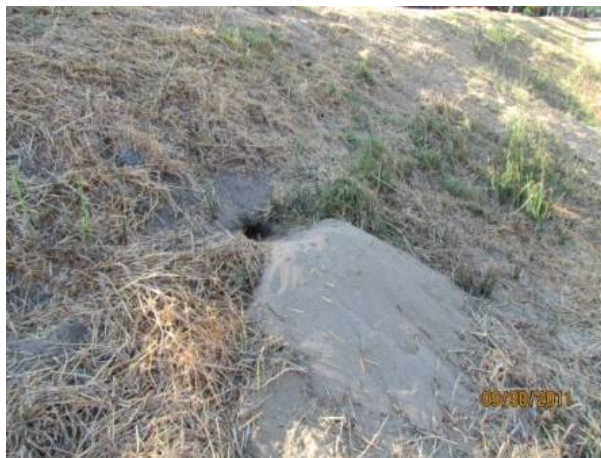
Levee Mile Report Line	32
Start Levee Mile	3.43
End Levee Mile	3.43
Location	Land Side
Category	Earthen Levee
Item	Animal Control

Rodent hole was found landside of the levee looking upstream.

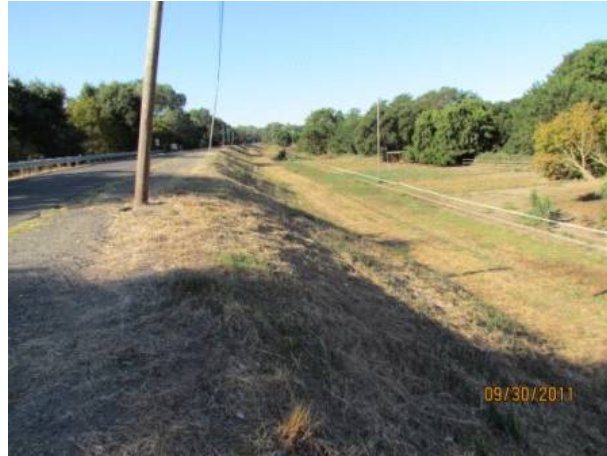
Levee Mile Report Line	33
Start Levee Mile	3.43
End Levee Mile	5.83
Location	Land Side
Category	Earthen Levee
Item	Vegetation
Vegetation on the landside of the levee is in acceptable condition. The picture was taken from the crown looking downstream.	
pkazi_f_20111107_175.jpg

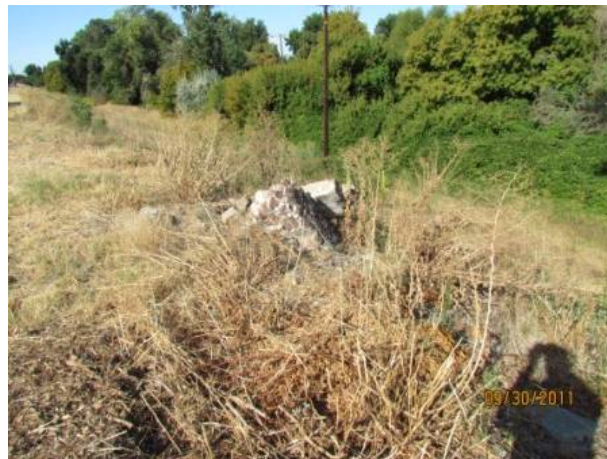
Levee Mile Report Line	39
Start Levee Mile	4.05
End Levee Mile	4.05
Location	Land Side
Category	Earthen Levee
Item	Encroachments
Concrete debris were found on the landside of the levee looking upstream.	
pkazi_f_20111109_177.jpg

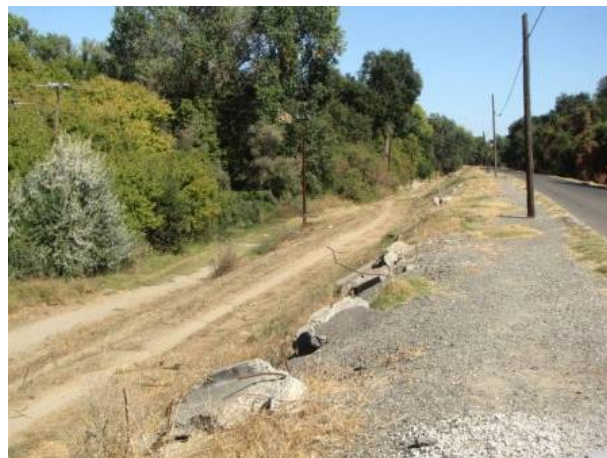
Levee Mile Report Line	40
Start Levee Mile	4.11
End Levee Mile	4.11
Location	Land Side
Category	Earthen Levee
Item	Encroachments
View of concrete debris with metal looking upstream.	
pkazi_f_20110923_399.jpg

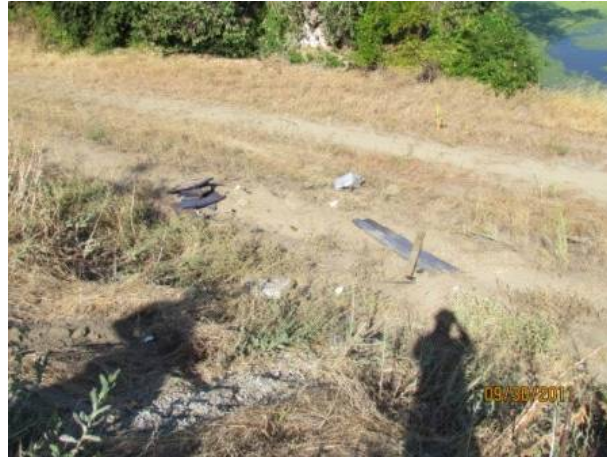
Debris were found on the landside toe of the levee. The picture was taken from the crown looking towards the toe.

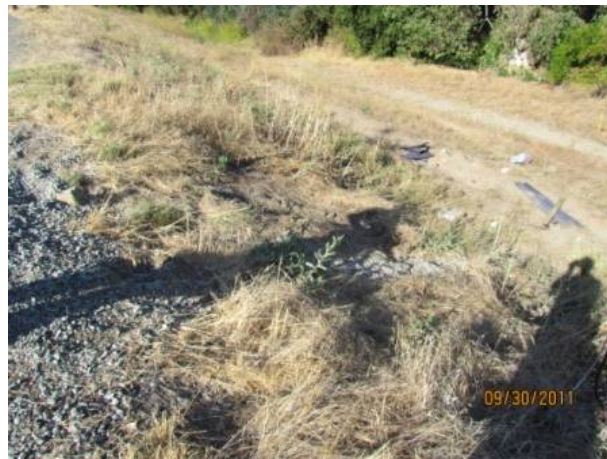
Levee Mile Report Line	42
Start Levee Mile	4.12
End Levee Mile	4.12
Location	Land Side
Category	Earthen Levee
Item	Slope Stability

Slope instability was caused by vehicular traffic on the landside slope of the levee. The picture was taken from the crown looking upstream.

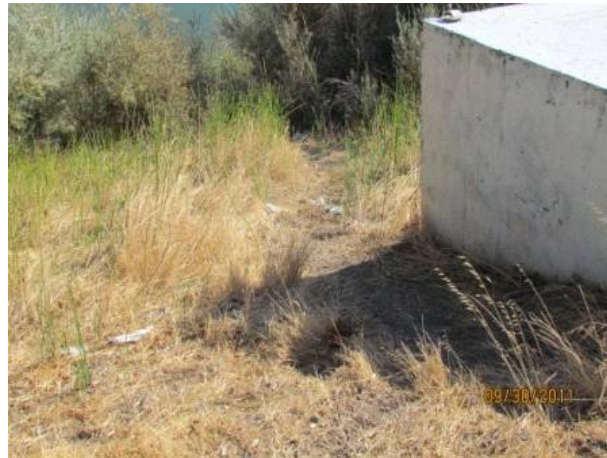
Slope instability was caused by foot traffic on the waterside slope of the levee looking upstream.

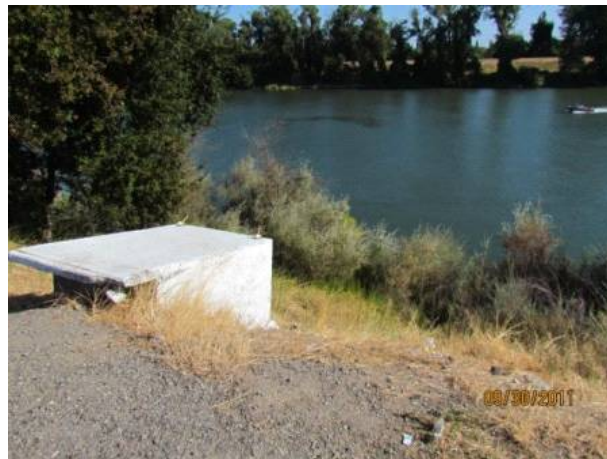
Levee Mile Report Line	47
Start Levee Mile	4.97
End Levee Mile	4.97
Location	Water Side
Category	Earthen Levee
Item	Encroachments

Concrete anchor was found on the waterside slope of the levee looking upstream.

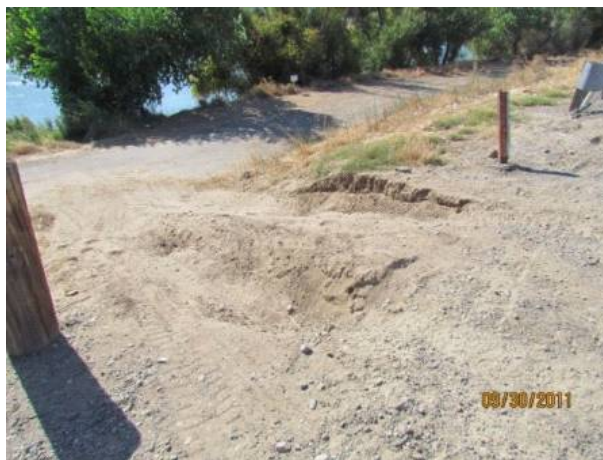
Slope instability was found on waterside of the levee looking upstream.

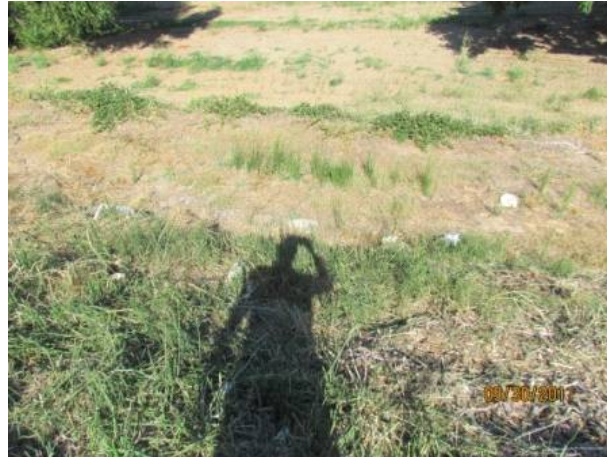
Debris were found on the landside of the levee. The picture was taken from the crown looking towards the toe.

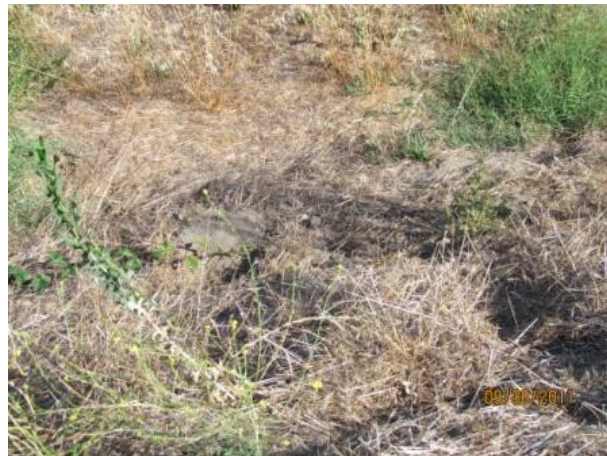
Levee Mile Report Line	62
Start Levee Mile	5.86
End Levee Mile	5.86
Location	Land Side
Category	Earthen Levee
Item	Animal Control

A rodent hole was found on the landside of the levee looking upstream.

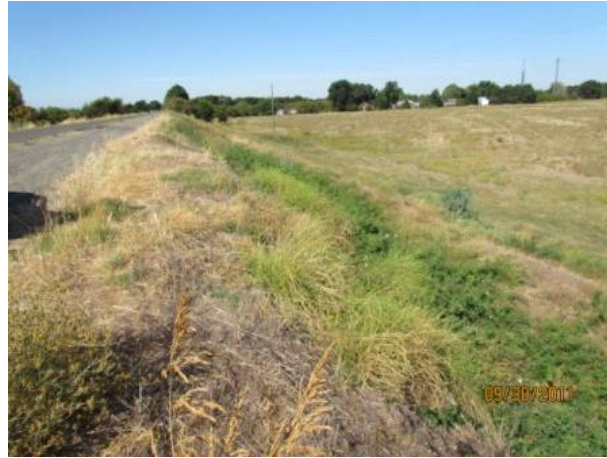
Wild growth was found on the landside of the levee looking upstream.

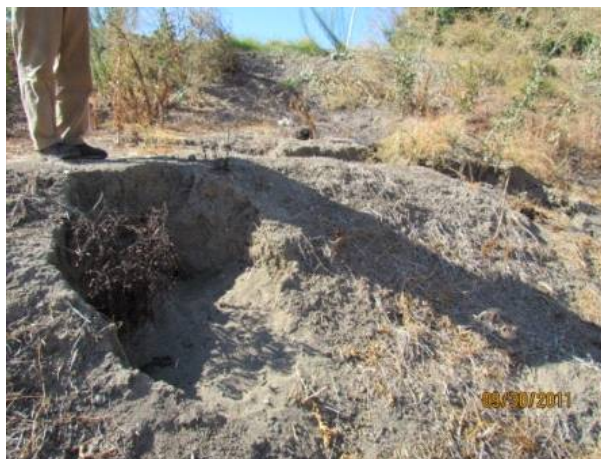
Levee Mile Report Line	67
Start Levee Mile	6.83
End Levee Mile	6.83
Location	Land Side
Category	Earthen Levee
Item	Slope Stability

Slope instability was found on the landside of the levee. The picture was taken from the toe looking towards the crown.

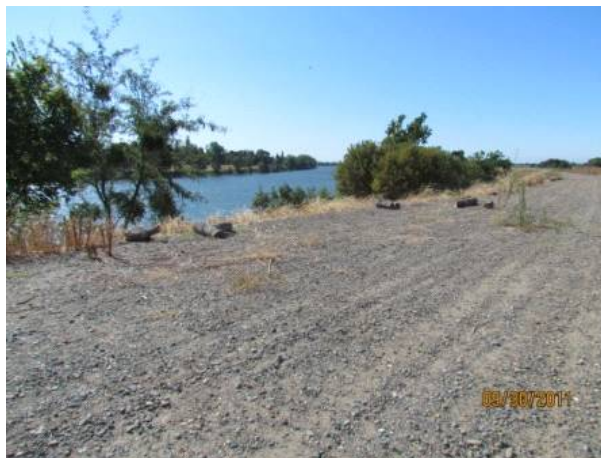
Levee Mile Report Line	68
Start Levee Mile	6.96
End Levee Mile	6.96
Location	Water Side
Category	Earthen Levee
Item	Encroachments

Firewood was found on the crown of the levee looking upstream.

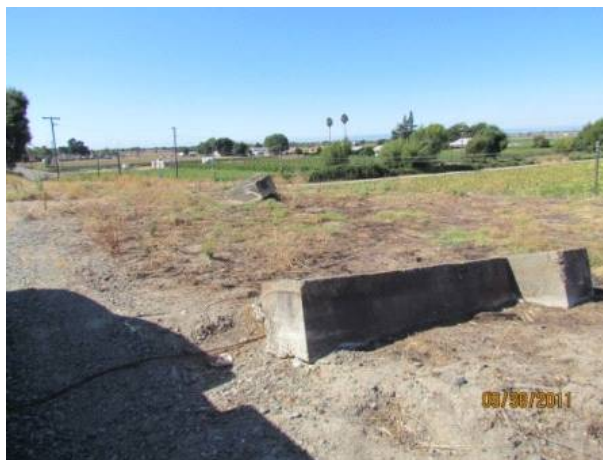
Concrete debris from old rail road track was found on the landside of the levee looking upstream.

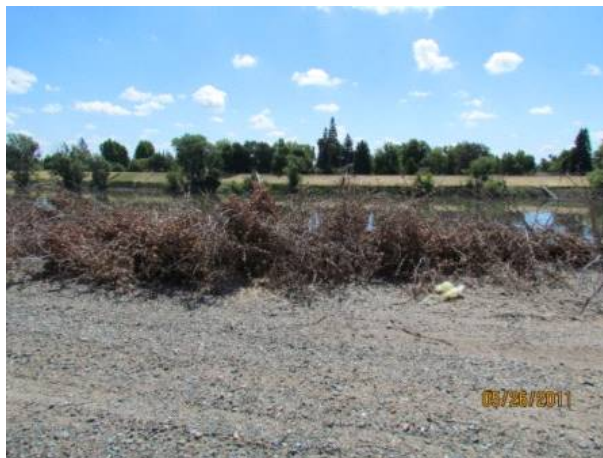
Levee Mile Report Line	72
Start Levee Mile	7.33
End Levee Mile	7.33
Location	Water Side
Category	Earthen Levee
Item	Encroachments

Prunings were found on the waterside of the levee. The picture was taken from the crown looking towards the river.

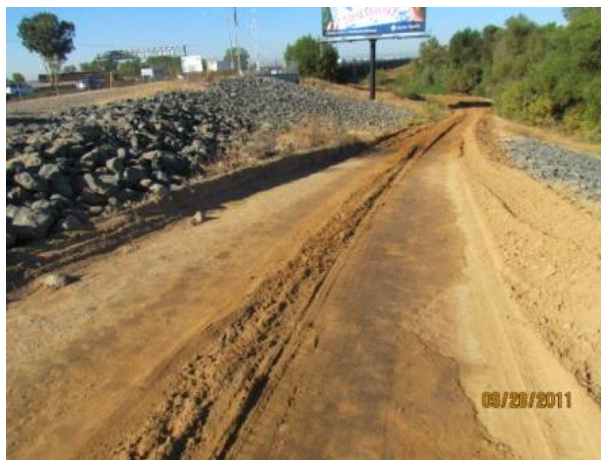
Levee Mile Report Line	3
Start Levee Mile	0.95
End Levee Mile	0.95
Location	Crown
Category	Earthen Levee
Item	Cracking

No cracking was found in this area during inspection. The picture was taken from the crown looking upstream.

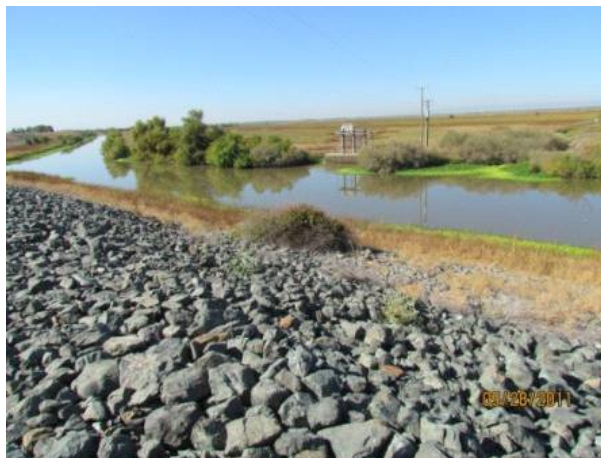
Levee Mile Report Line	7
Start Levee Mile	2.45
End Levee Mile	2.45
Location	Water Side
Category	Earthen Levee
Item	Encroachments

Prunings were found on the waterside of the levee looking upstream.

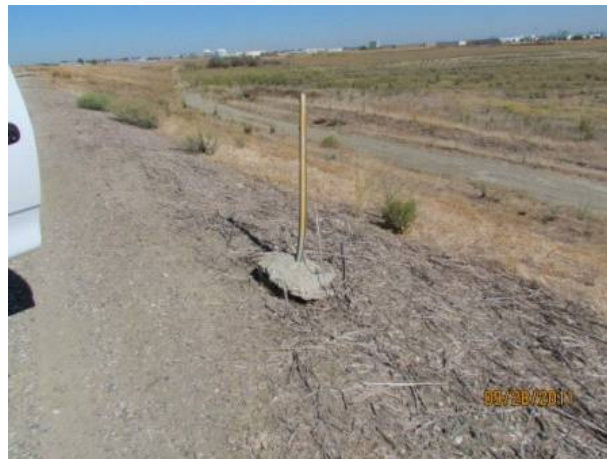
Levee Mile Report Line	9
Start Levee Mile	3.12
End Levee Mile	3.12
Location	Land Side
Category	Earthen Levee
Item	Encroachments

Abandon pole was found on the landside of the levee looking upstream.

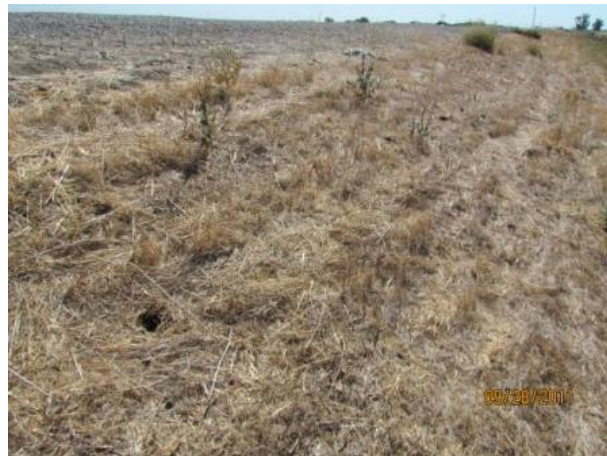
Levee Mile Report Line	10
Start Levee Mile	3.12
End Levee Mile	3.12
Location	Water Side
Category	Earthen Levee
Item	Animal Control

A rodent hole was found on the waterside of the levee. The picture was taken from toe of the levee looking upstream.

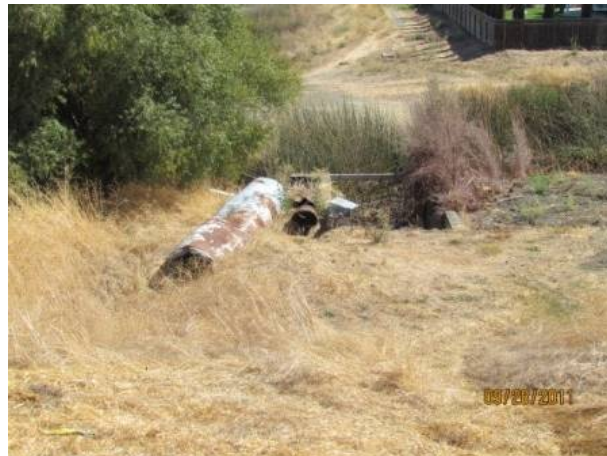
Levee Mile Report Line	14
Start Levee Mile	3.26
End Levee Mile	3.26
Location	Land Side
Category	Earthen Levee
Item	Encroachments

Abandon pipes and debris was found on the landside of the levee looking upstream.

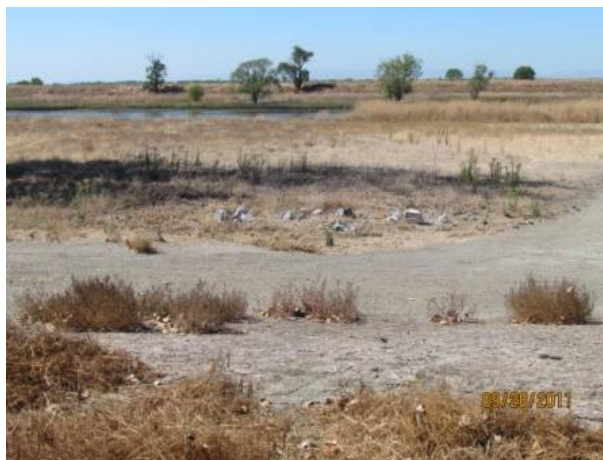
Concrete debris was found on the waterside of the levee looking upstream.

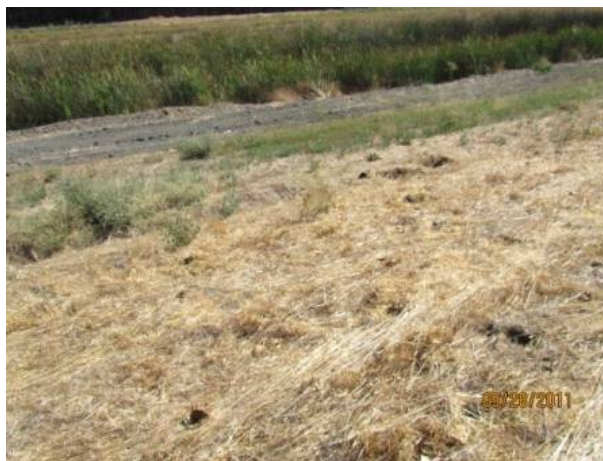
Levee Mile Report Line	16
Start Levee Mile	3.61
End Levee Mile	3.61
Location	Land Side
Category	Earthen Levee
Item	Animal Control

Rodent holes were found on the landside of the levee looking upstream.

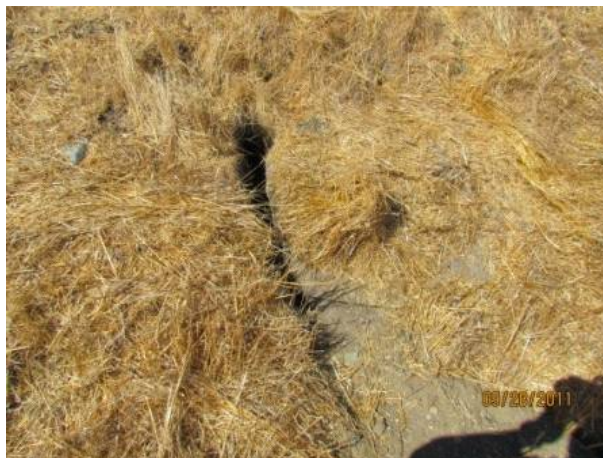
Levee Mile Report Line	17
Start Levee Mile	3.70
End Levee Mile	3.70
Location	Land Side
Category	Earthen Levee
Item	Animal Control

Rodent hole was found on the landside slope of the levee. The picture was taken from the toe of the levee looking upstream.

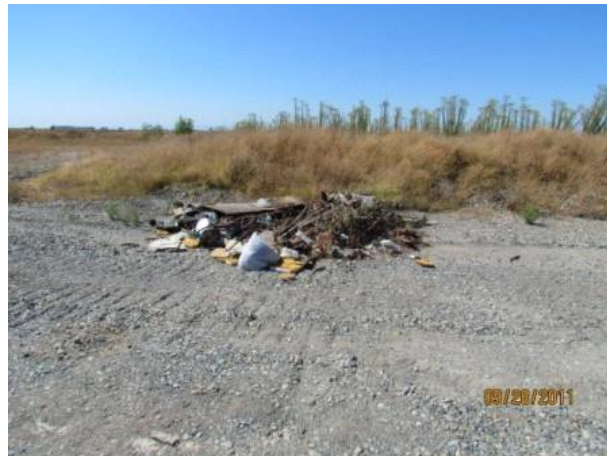
Levee Mile Report Line	27
Start Levee Mile	5.06
End Levee Mile	5.06
Location	Water Side
Category	Earthen Levee
Item	Encroachments

Debris was found on the waterside of the levee looking upstream.
